CALIFORNIA DIVISION OF MINES AND GEOLOGY

Supplement no. 2 to Fault Evaluation Report FER-42

April 24, 1978

1. Unnamed fault in West Coyote Hills.

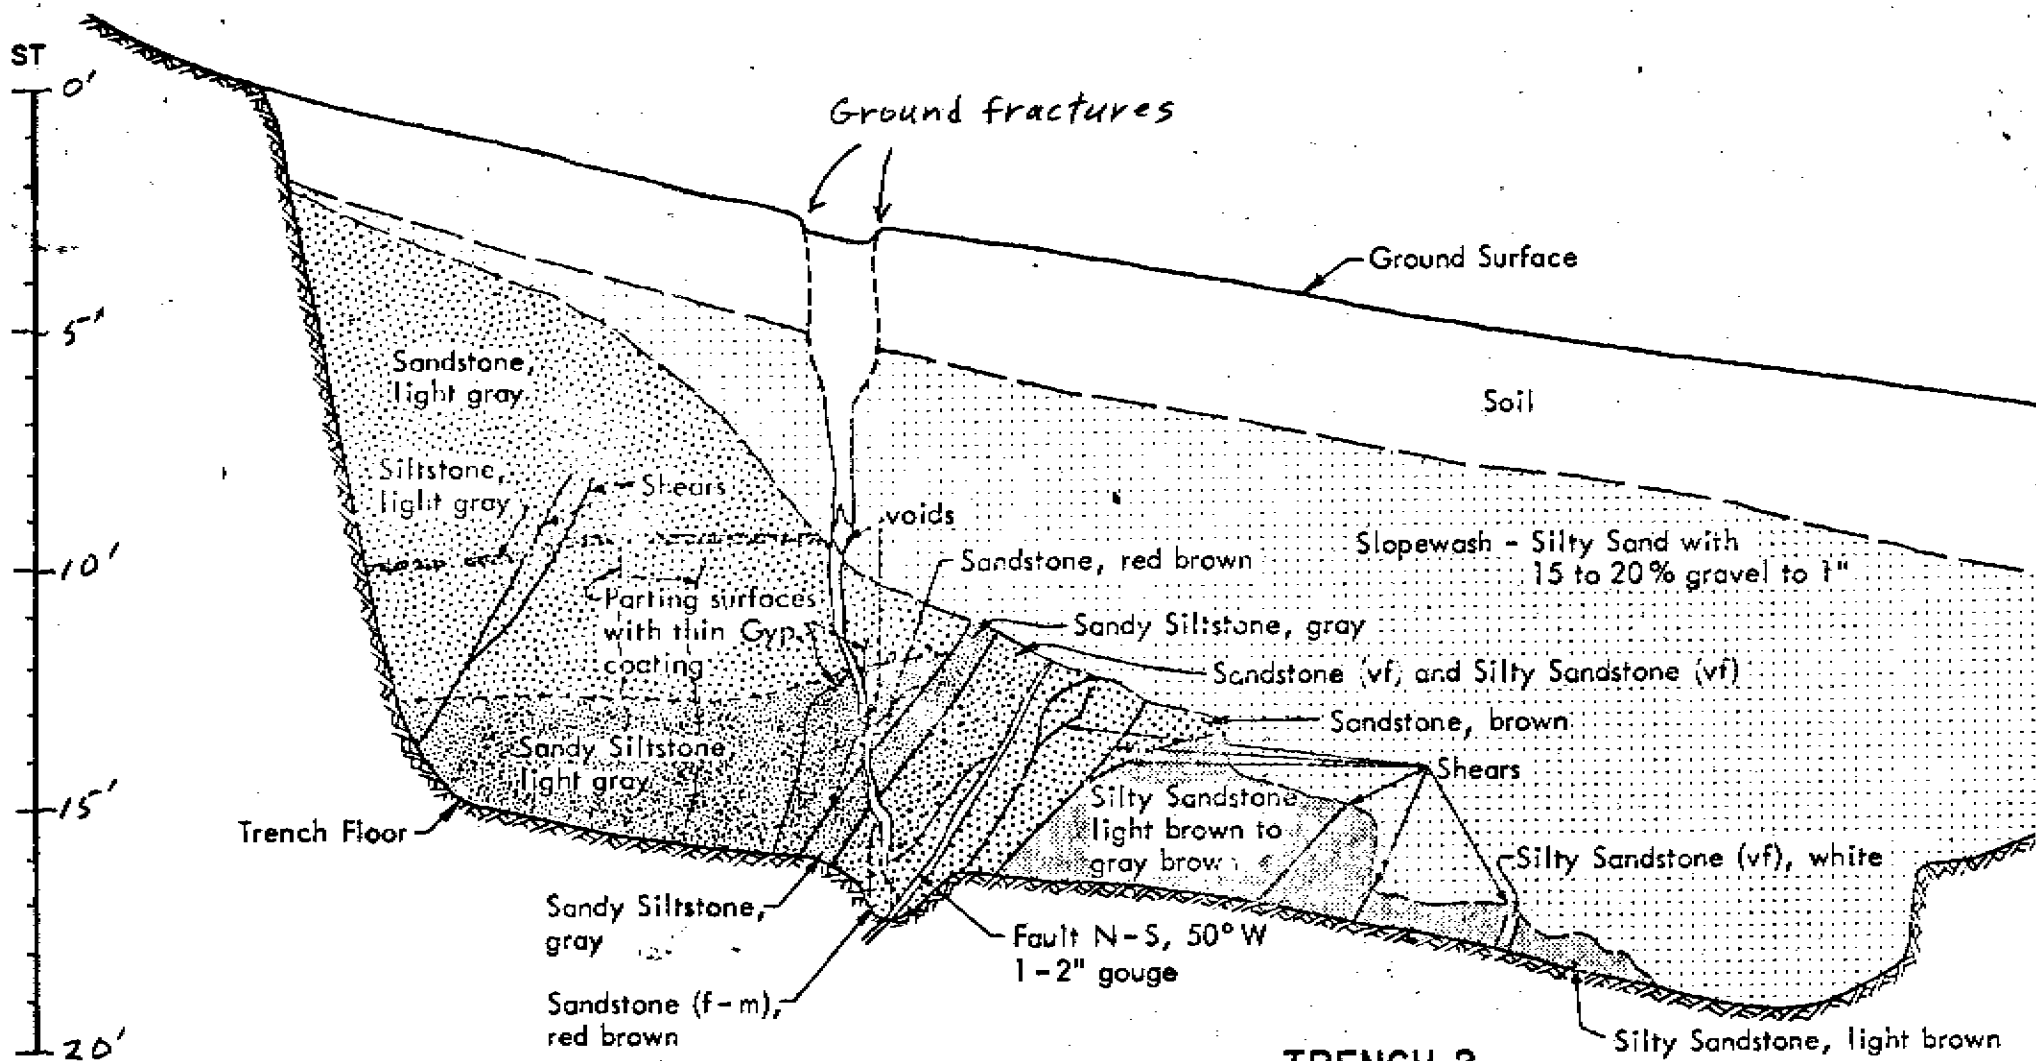
TRENCH 2
LOOKING NORTH
Scale: 1" = 4'

Typically, the 1968 fractures were open fissures that overlay bedrock faults (e.g. see figure 6). The open fissures are nearly vertical, coincide with the mapped ground fractures, and indicate extensional opening in trenches TR-1 to TR-4. The underlying bedrock faults in trenches TR-1 and TR-2 mainly dip steeply to the west. Bedrock (Pleistocene) faults also were identified in TR-7 to TR-10, but no historic fractures were reported. In TR-7, the fault zone is 4.5 feet wide, diminishing to a series of minor shears in TR-10. The consultant speculates that fault "A" joins fault "B" 400 feet to the north. The description of the 1968 ground ruptures by Yerkes (1972, p. C31) contrasts somewhat with the above in that Yerkes observed evidence of an east-dipping reverse fault with a component of left-lateral movement (right-stepping fractures). Converse, Davis and Associates (1970a, 1970b) clearly identified open fractures ^{above} ~~with~~ a pre-existing west-dipping to vertical fault.

supplement
Figure 6 (FER-42_N) — Log of trench 2 (see Fig. 5
for location) showing relationship between ground
fractures and bedrock fault (from Converse, Davis
& Assoc., 1970b).
